**NEW MEXICO
ENVIRONMENT DEPARTMENT**

**Re: Gadsden Independent School District; Minor Non-Municipal; SIC 4952; NPDES
Compliance Evaluation Inspection; NM0028487; May 12, 2016**

NPDES Compliance Inspection Report

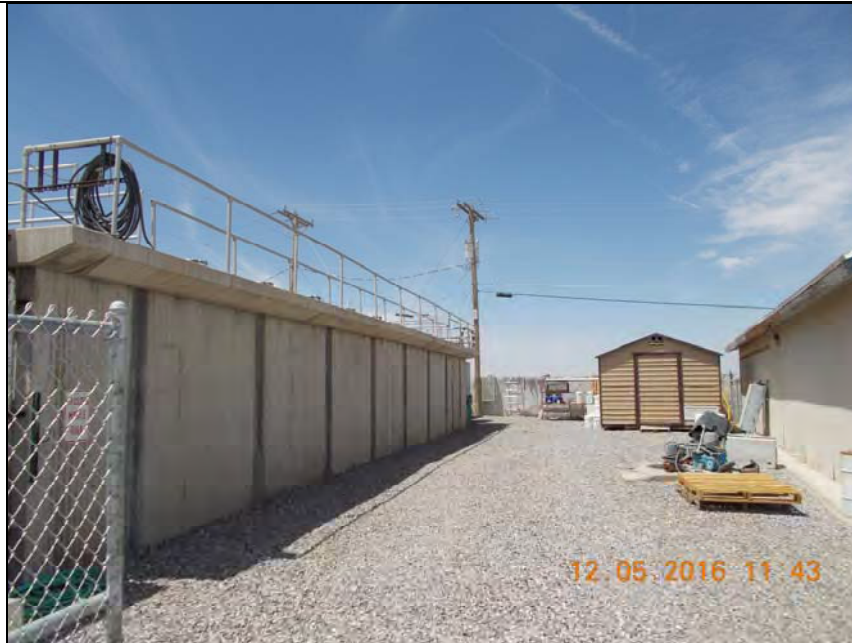
**MED/SWQB
Official Photograph Log
Photo # 1**

Photographer: B. Cooney	Date: May 12, 2015	Time: 11:43 Hours
City/County: Anthony / Dona Ana		State: New Mexico
Location: Gadsden Middle School Wastewater Treatment Plant		
Subject: Gadsden Middle School – above ground aeration basin

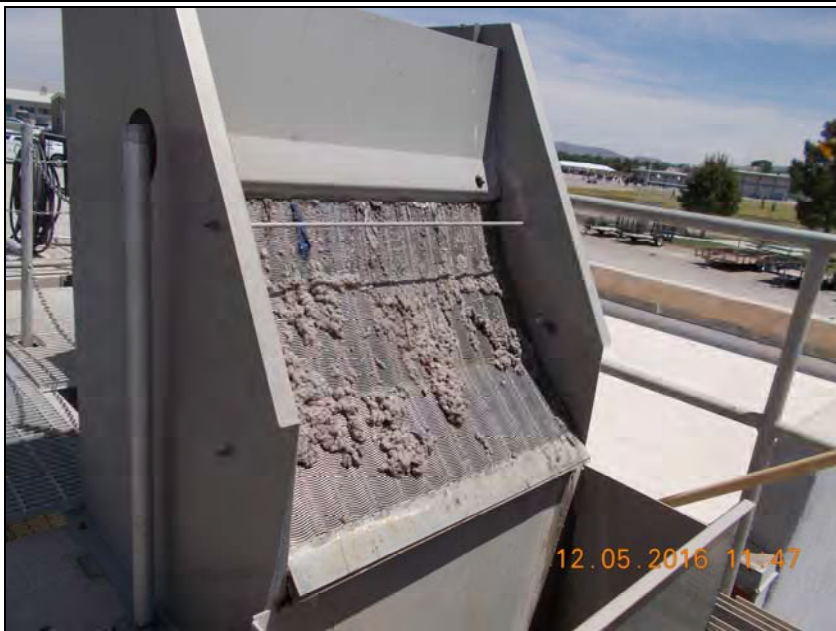
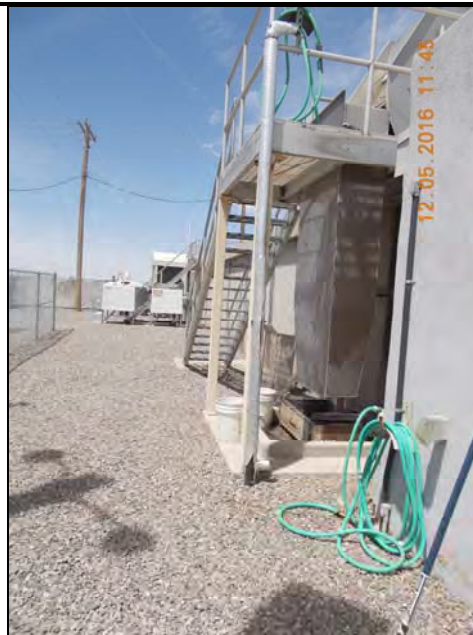
**NMED/SWQB
Official Photograph Log
Photo #3 &4**

Subject: Influent screen removes large solids. These solids are sent down a chute as seen in photo # 4 and are deposited in a hopper for disposal at the landfill. The area was clean and free of debris.

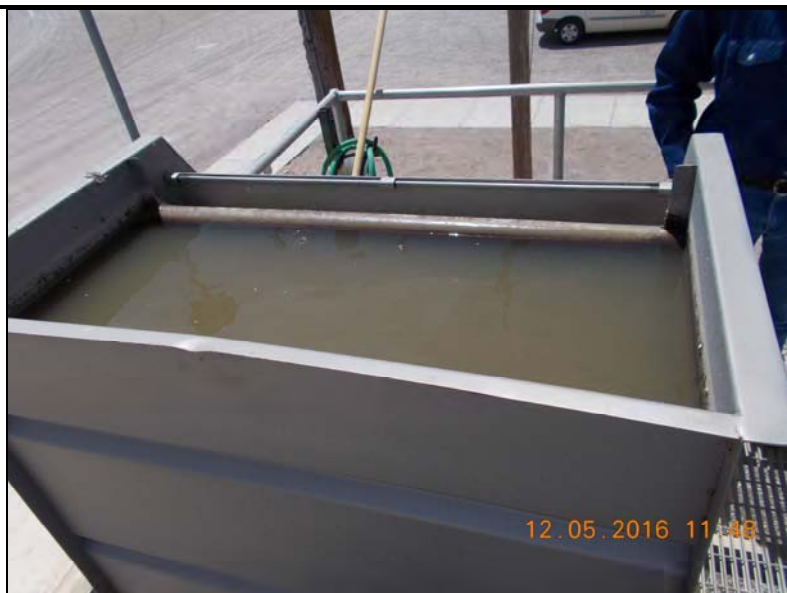
**NMED/SWQB
Official Photograph Log
Photo #5**

Subject: Influent after screening is sent from this basin to the aeration basin.

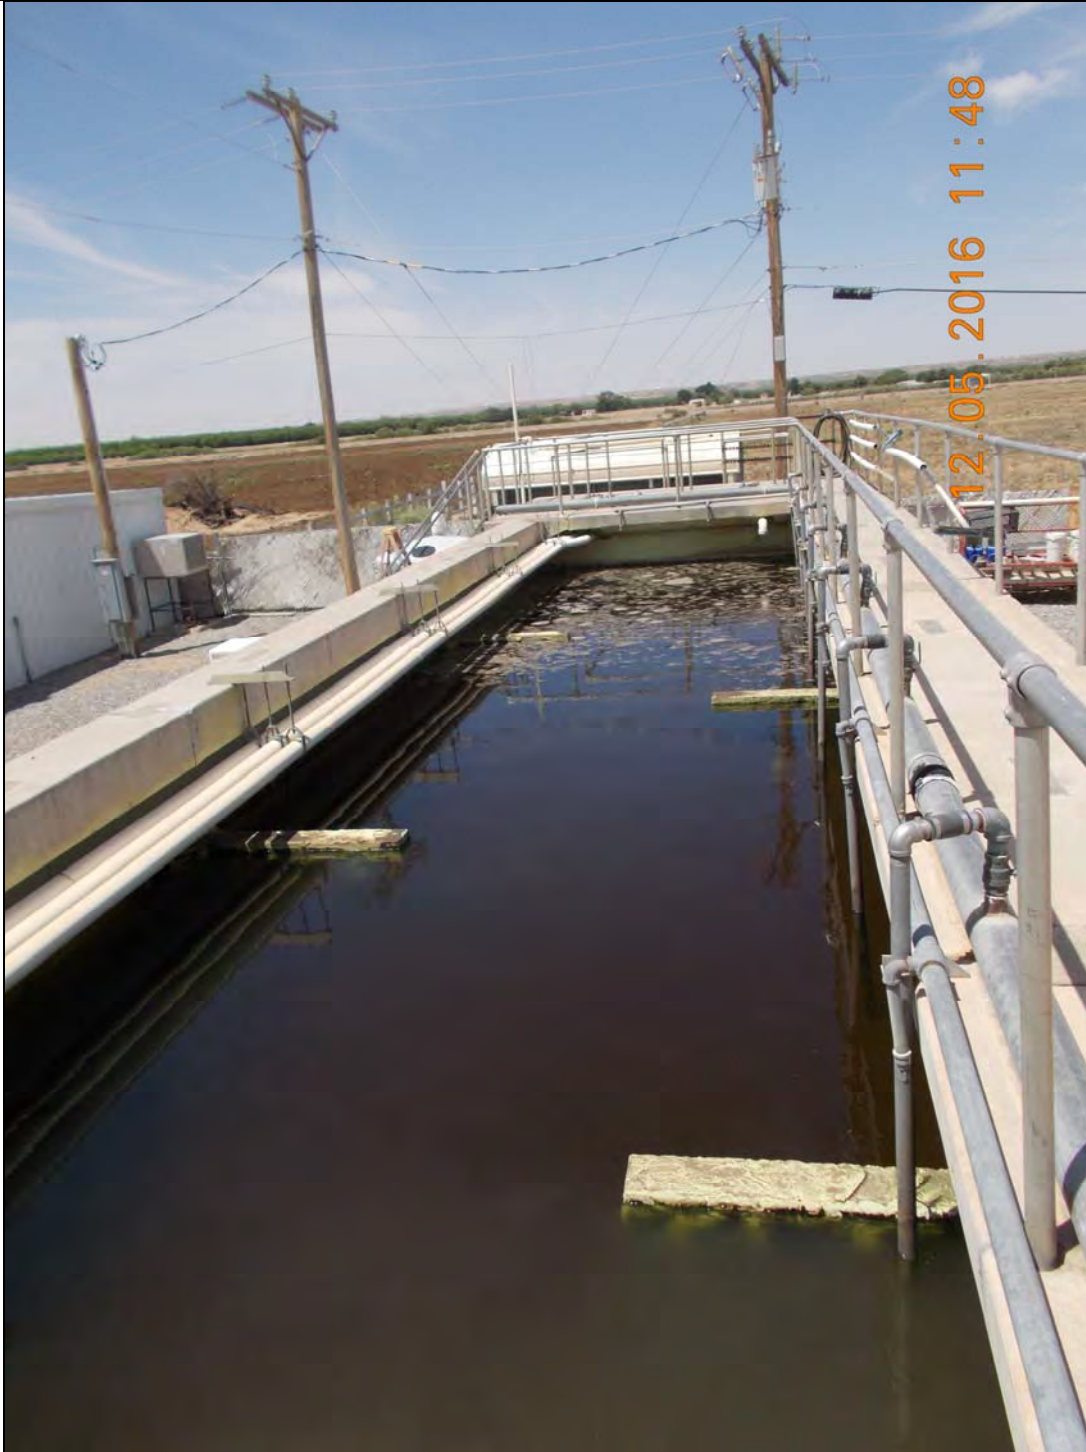
**NMED/SWQB
Official Photograph Log
Photo # 6**

Subject: Aeration Basin during the anoxic and settling phase, there are bulking solids in the basin, indicating very old solids. According to the operator, solids are wasted two to three times per year. At the time of the inspection the Mixed Liquor Suspended Solids (MLSS) were unknown. The aeration phase is 3-4 hours and settling is 1-2 hours according to the operator.

- All forms are retained in multiple form and submitted with DMR's.
- 2.) Marginal rating: Operations and Maintenance
 - *Treatment units were observed to have overloaded solids at both treatment plants, more wasting is recommended. Wasting is conducted three times per year for both plants. However, more frequent measurement and monitoring standards have been implemented. The District is prepared to increase the wasting by*

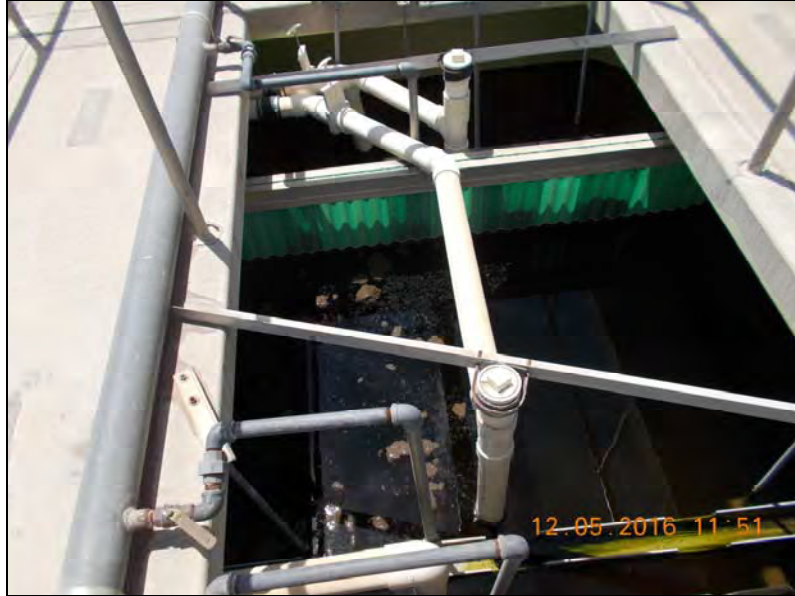
**NMED/SWQB
Official Photograph Log
Photo # 7**

Subject: Secondary clarifier had bulking solids and some floating solids in the basin.

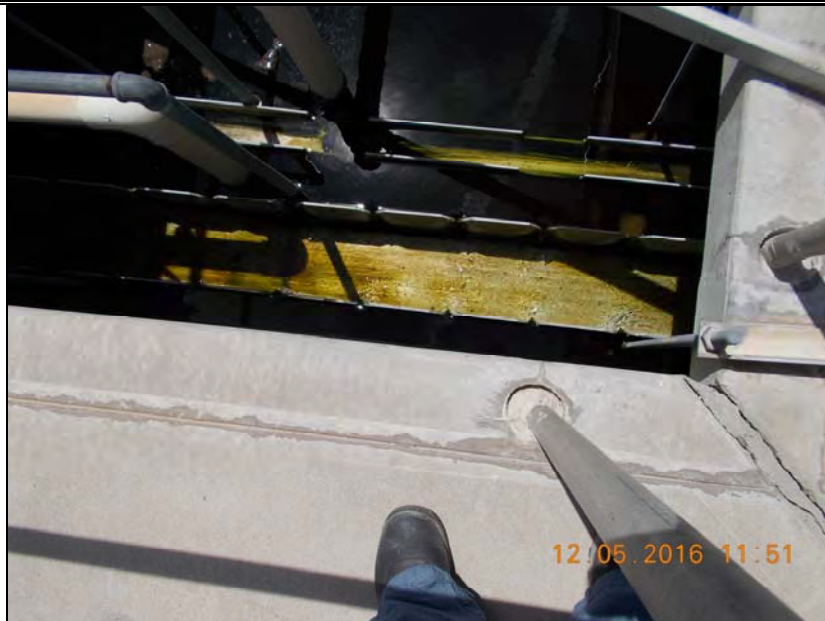
**NMED/SWQB
Official Photograph Log
Photo # 8**

Subject: Secondary clarifier weirs.

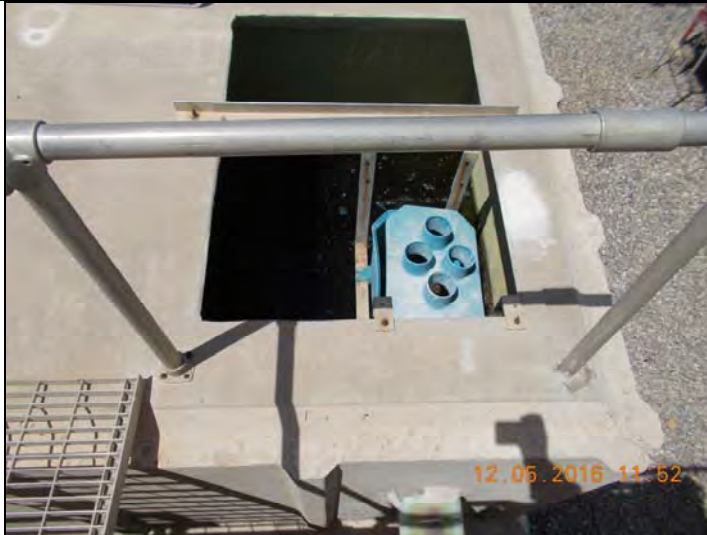
**NMED/SWQB
Official Photograph Log
Photo # 9**

Subject: The old chlorine contact chamber is a solids settling and liquid pass through basin now. No chlorine is used at the facility now that a new Ultraviolet disinfection system is in place. Solids should be vactored out of the bottom of this basin as well as from the clarifier on occasion.

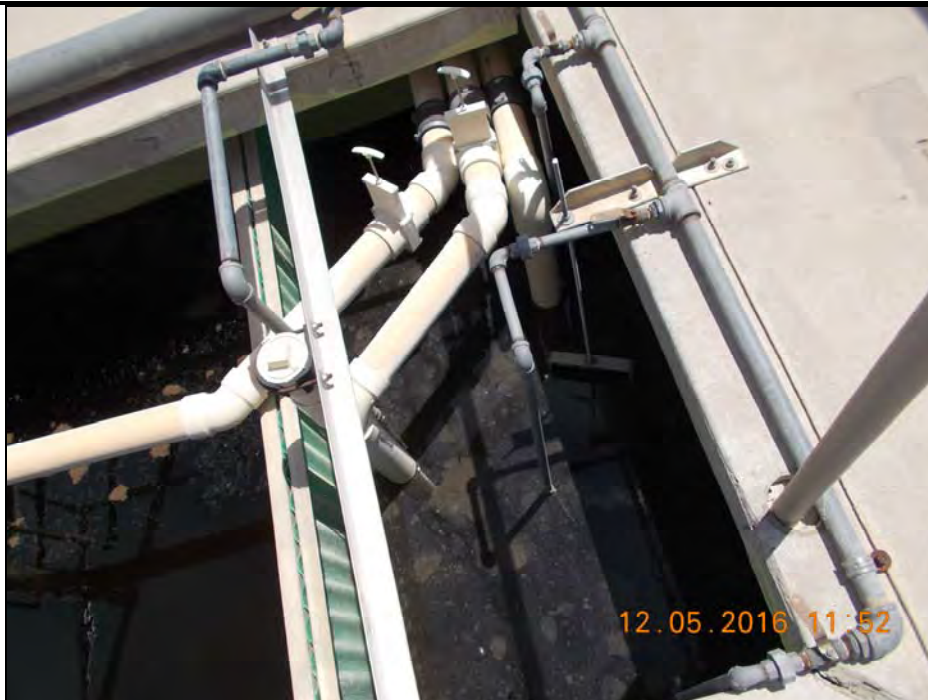
**NMED/SWQB
Official Photograph Log
Photo # 10**

Subject: Another view of the secondary Clarifier with floating solids. Surface baffles contain some but not all solids as the water passes through this unit.

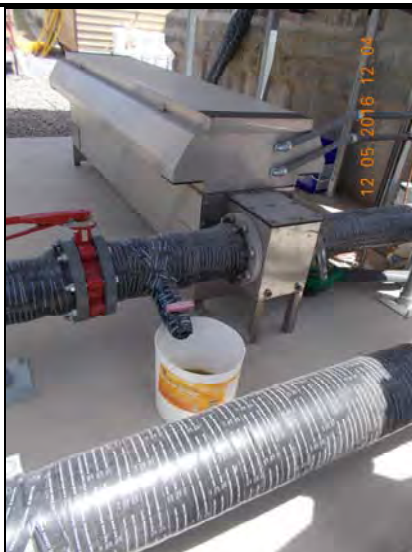
**NMED/SWQB
Official Photograph Log
Photo # 12**

Subject: Effluent sampling port following the final treatment unit, the Enaqua ultraviolet disinfection system. From this location the flow is sent to the outfall at the Rio Grande. Both the treated water from the junior high school and the high school pass through this system and are sampled following treatment.

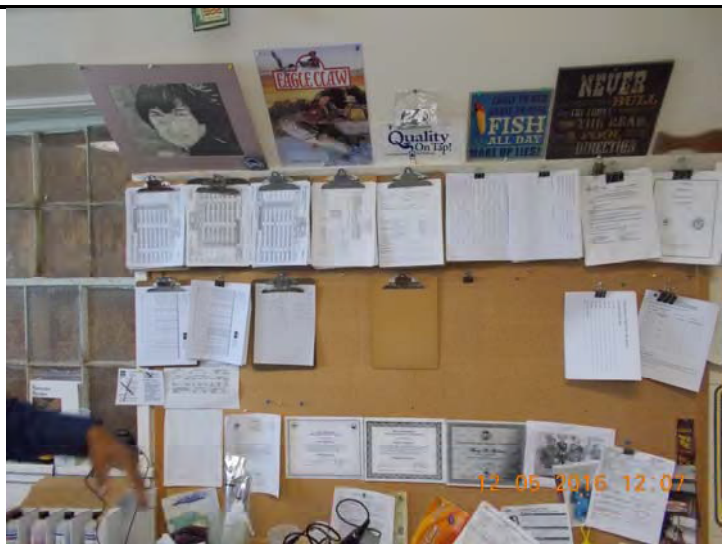
**NMED/SWQB
Official Photograph Log
Photo # 13 & 14**

Subject: On site laboratory and operators office - Daily logs and sampling records are maintained and easily identified. Once logs have been completed they are placed in a well-organized file system. Operators were easily able to provide the inspector with requested records.

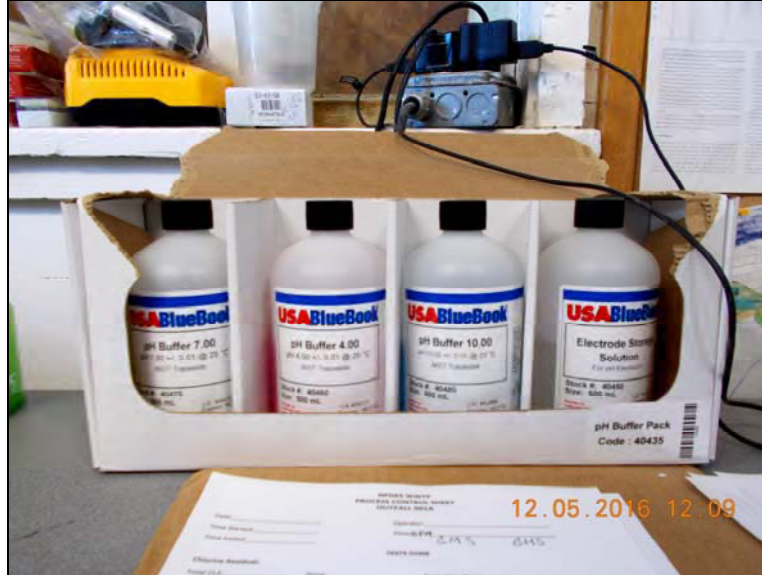
**NMED/SWQB
Official Photograph Log
Photo # 15**

Subject: pH buffers should have the date received and the date opened written on the bottles.

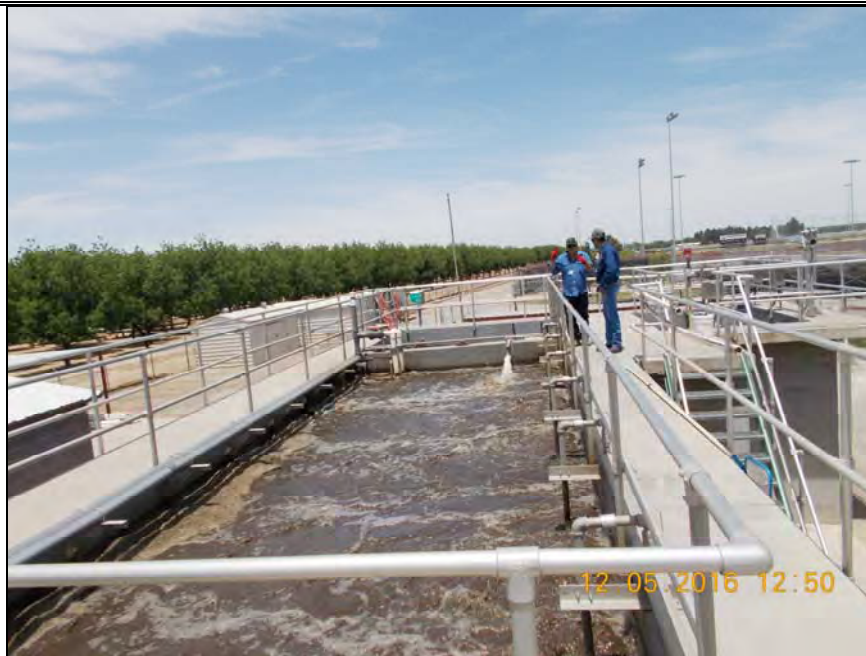
**NMED/SWQB
Official Photograph Log
Photo # 16**

Subject: High school treatment plant and aeration basin in the air is well diffused throughout the basin.

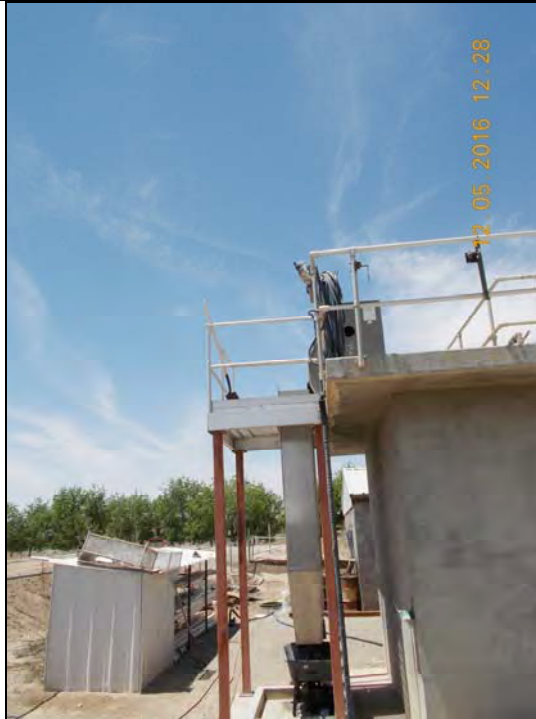
**NMED/SWQB
Official Photograph Log
Photo # 17**

Subject: The influent solids are removed by a screening system similar to that used at the junior high school and deposited in a wheelbarrow in a contained area before being disposed of at the landfill. The area was clean and free of debris.

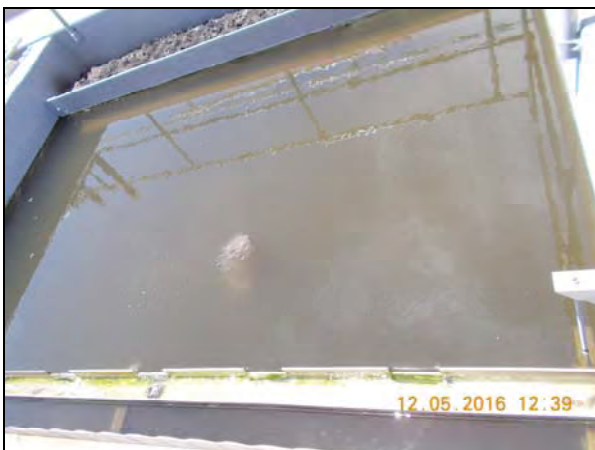
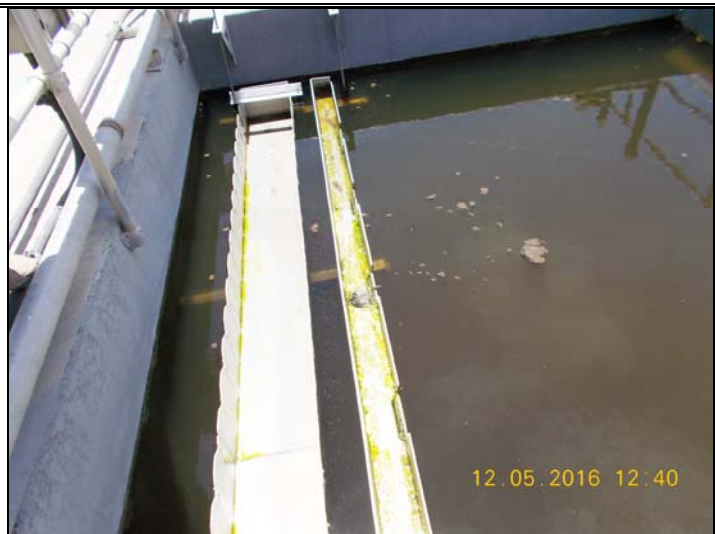
**NMED/SWQB
Official Photograph Log
Photo # 18 & 19**

Floating solids were observed in the secondary clarifier of the high school WWTP. A baffle was installed in the basin where the Flygt pumps are located to prevent these floating solids from being sent to the UV disinfection treatment unit at the junior high school. Though some solids appeared to get past the baffles.

Subject: Solids in the secondary clarifier throughout the water column are an indication of inadequate wasting. Floating solids with grey appearance indicate old solids.

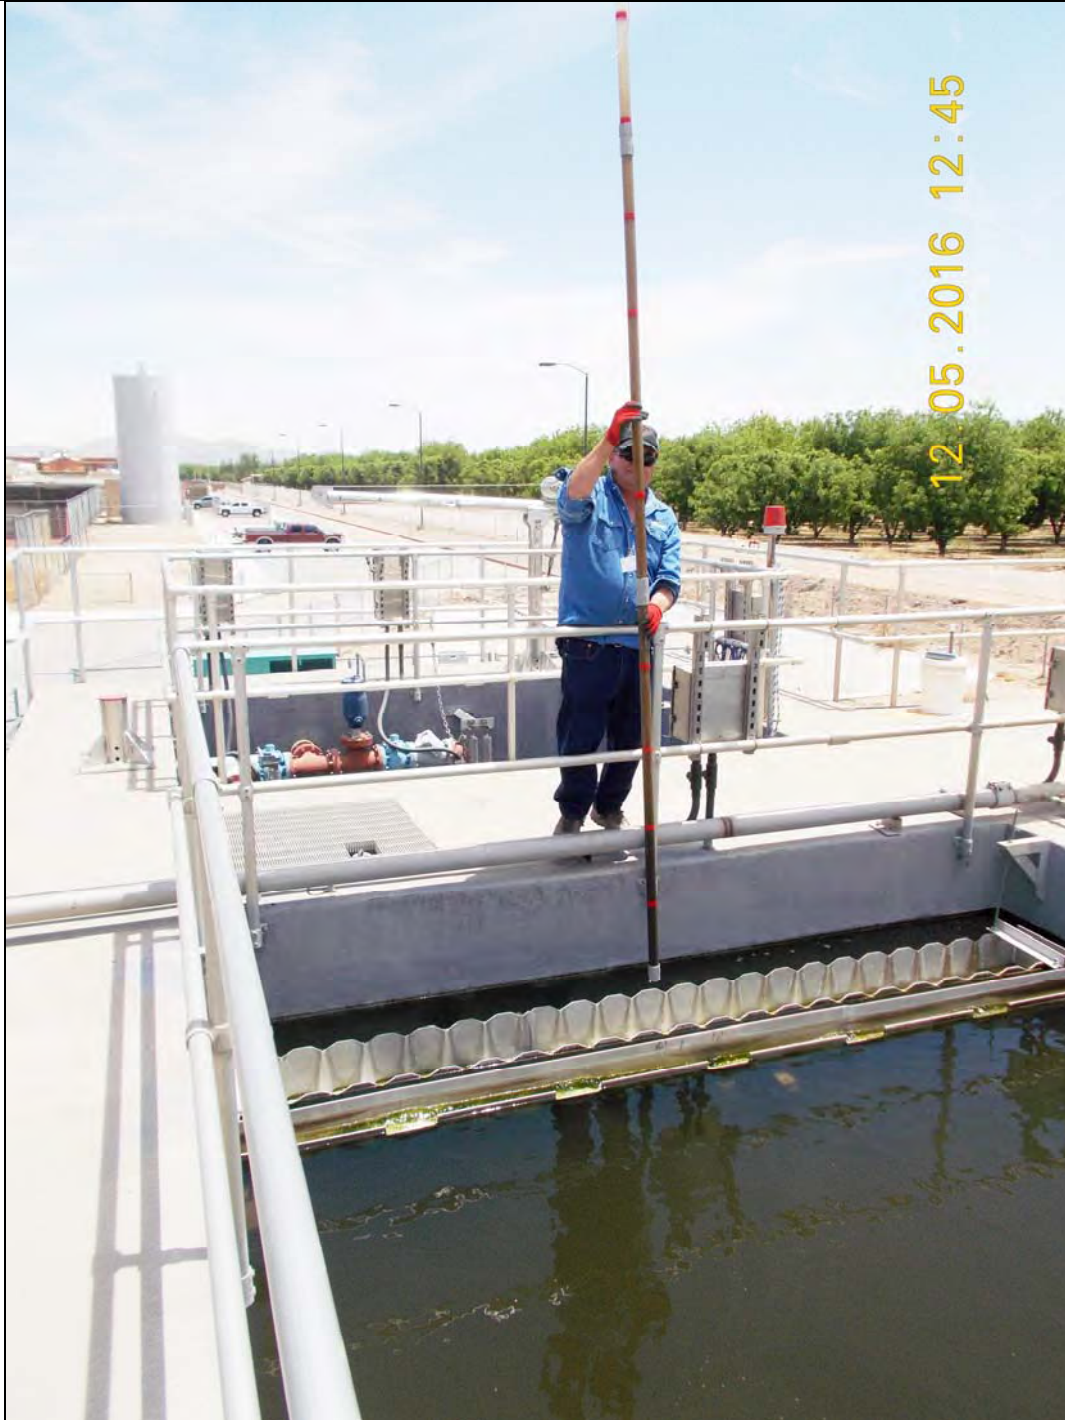
**NMED/SWQB
Official Photograph Log
Photo # 20**

Subject: Secondary clarifier had a 10 foot sludge blanket with a few more feet of a diffuse layer above. Based on the inspector's best professional judgement, this approximately 13 foot deep basin should be maintained with a sludge blanket of no more than 3 feet to operate most efficiently. Return Activated Sludge (RAS) is sent back to the aeration basin several times a day, though disposal of additional Waste Activated Sludge (WAS) is necessary.

- *Treatment units not properly maintained. 10' sludge blanket at GHS Plant due to solid removal inadequacy.* In May 2016, the GHS Plant was struggling with influent being over diluted due to several possible factors such as leaky water faucets and flush valves on toilets not operating properly. The over dilution prevented the natural breakdown of the solids. Since the inspection, necessary repairs have been conducted to decrease the over diluted influent. In addition, staff has been supplementing the plant with 10 lbs of Carmelyx added weekly in the aerating chamber.

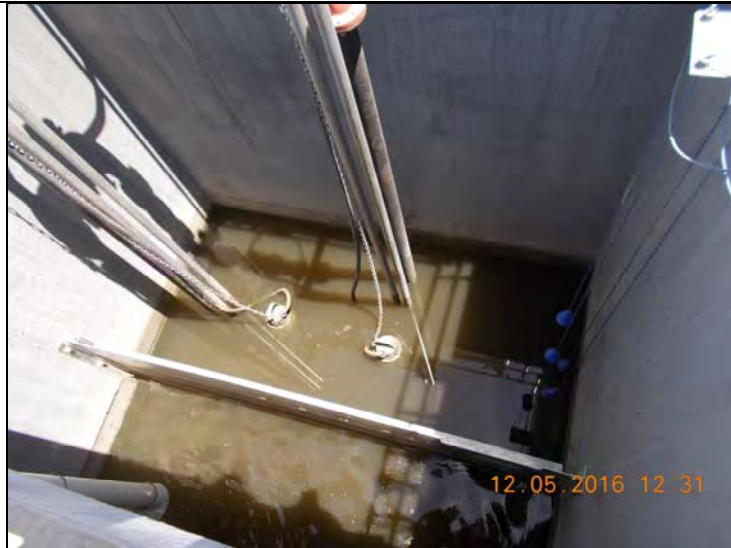
**NMED/SWQB
Official Photograph Log
Photo # 21**

Subject: Two Flygt pumps lift the treated wastewater from the high school and send it through a forced main to the junior high school where disinfection is done with the same Enaqua system. Operators have installed a surface baffle to capture floating solids before they reach the pumps. The effluent following clarification is very turbid as can be seen in the photo below. This is an indication of incomplete solids removal and too much sludge in the clarifier.

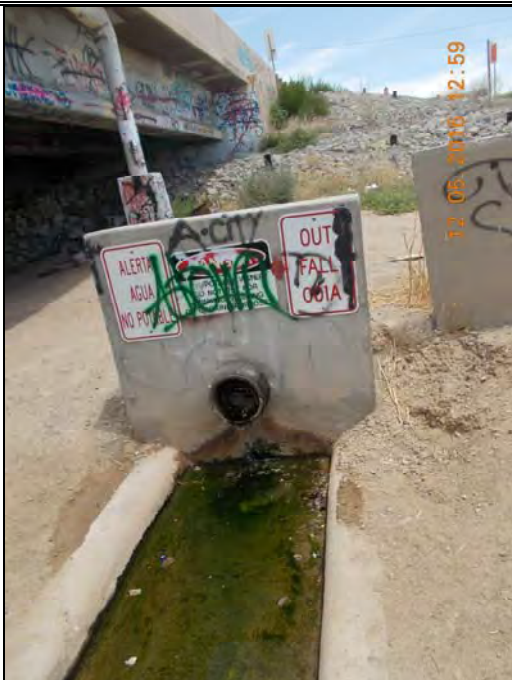
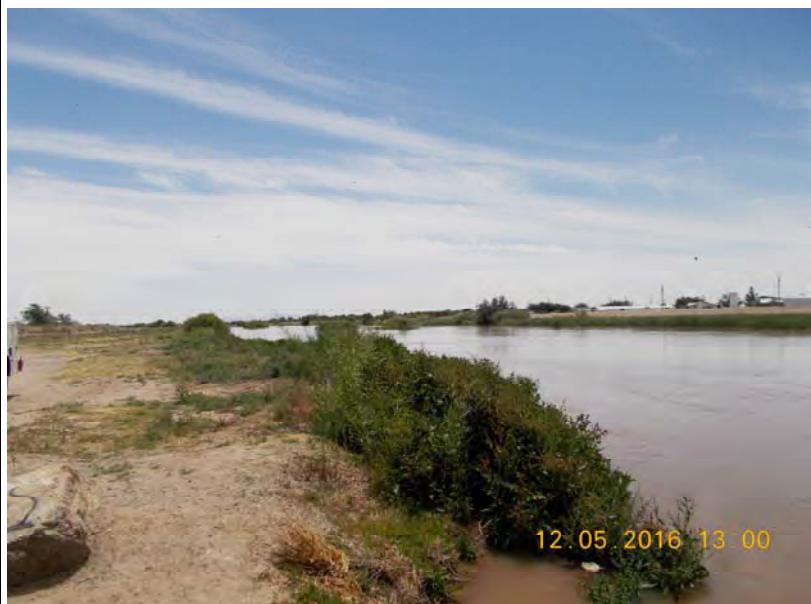
**NMED/SWQB
Official Photograph Log
Photo # 22 & 23**

Subject: Final outfall for both the middle school and the high school at the Rio Grande
